# BELZONA SEALS SULFUR HEXAFLUORIDE LEAKS

**Industry:** Power  
**Application:** VPF-Valves, Pipes and Fittings  
**Substrate:** Aluminium  
**Products:** \* Belzona® 1111 (Super Metal) ,  
\* Belzona® 3921 (GSC Surface Conditioner) ,

**Customer Location:** Electric distributor in Australia.  
**Application Date:** February 2001

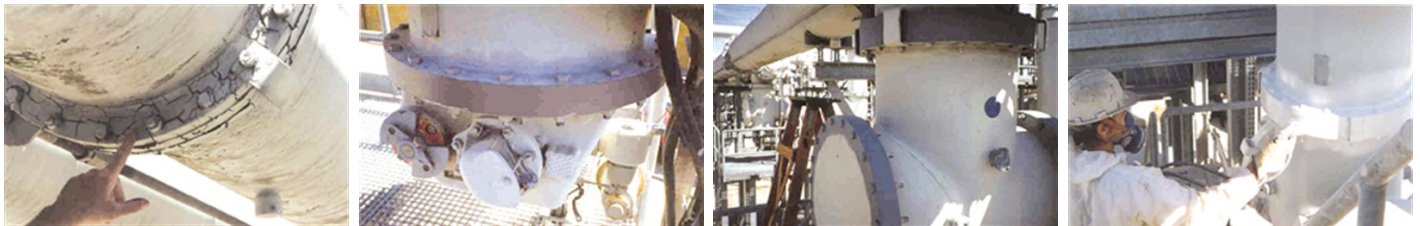
## Photograph Descriptions

*Leakage at flange joints due to breakdown of the original mastic sealer. There was also a breakdown of the original paint system on the equip-ment.*

- \* Existing joints showing failed paint system ,
- \* Belzona® 1111 applied to seal joint ,
- \* Area primed with Belzona® 3921 ,
- \* Spray application of paint system to complete the application ,

After blasting to remove existing coatings and mastic, Belzona® 1111 was used to seal the flange joint. Belzona® 3921 was then applied to create a base for a conventional paint that was spray applied to the area.

A laser leak detection camera on the sealed flanges has revealed no leaks, and an order has been received for all 515 flanges on the site due to the success of the first application.
