BELZONA PROTECTS FLARE DRUM

ID: 2740

Flare knock-out drum

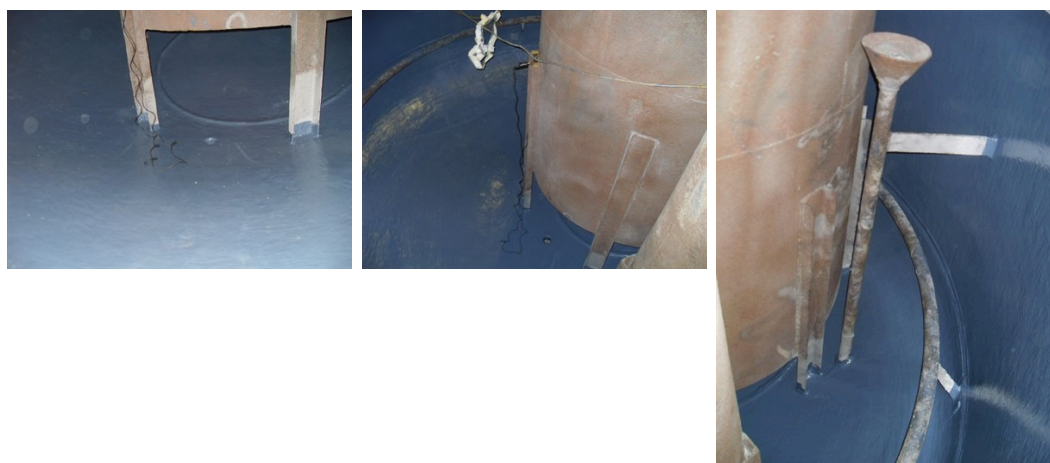
Vessel suffering internal corrosion. Coating required to extend service life of the vessel.

* 1, 2 & 3. various views of the Belzona® 1391 applied to the vessel interior. ,

Application was carried out in accordance with Belzona Know-How System Leaflet TCC-5.

Belzona® 1391 provides excellent corrosion protection at elevated temperatures. In particular the coating is capable of withstanding the extreme variations in temperature and pressure the vessel is exposed to. The ambient temperature curing coating lends itself to application on-site.
