BELZONA RESTORES LOCAL BANK

ID: 2776

Application: WPA-Wall Problem Areas

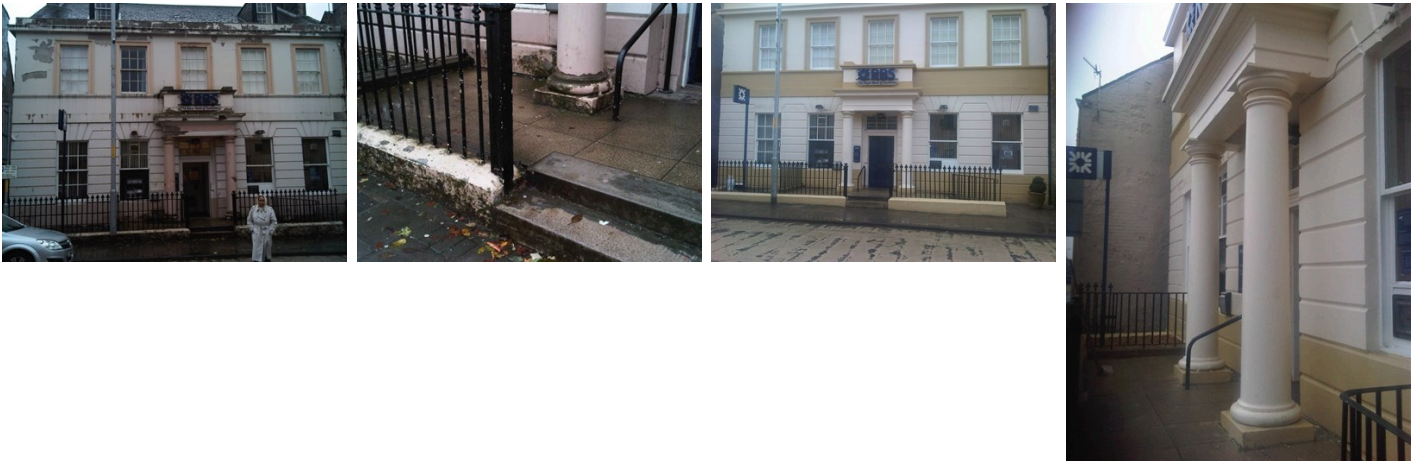
Photograph Descriptions

Age and the effect of weather had caused serious deterioration to the buildings facade.

- * Fascia of the building prior to application ,
- * Damaged Column ,
- * General view of the completed application ,
- * The refurbished bank entrance ,

Application was carried out in accordance with Belzona Know-How System Leaflets WPA-1 and WPA-4. The defective external wall coatings were removed. Some of the broken profiles around the windows and the lintel above the front door were repaired with Belzona® 4141. Belzona® 5151 was then applied to the stonework to protect the surface from further damage.
