FLANGE SEALING WITH BELZONA

ID: 2785

Customer Location: *Salt producer, Germany*
Application Date: *May 2010*

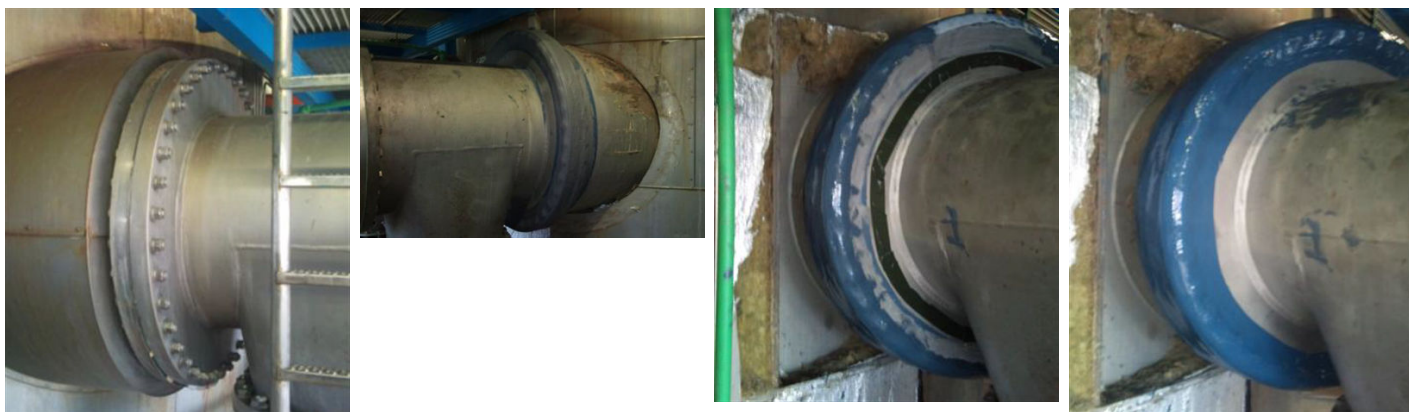
Photograph Descriptions

The leaking flange had to be sealed without dismantling as production could not be interrupted.

- * Leaking flange ,
- * Application of first coat ,
- * Application of second coat ,
- * Complete application ,

Large leaking flange

Application was carried out in accordance with an adapted version of Belzona Know-How System Leaflet VPF-11. After grit blasting, the nuts and bolts were encapsulated with Belzona® 1111 before Belzona® 1391 was applied by brush, incorporating Reinforcement Tape, to completely seal the circumference of the flange joint.

The application was completed in two days and has created a heat resistant seal without having to dismantle the flange. This ensured minimal disruption to production.
