# FLANGE SEALING WITH BELZONA

ID: 2785

**Customer Location:** Salt producer, Germany  
**Application Date:** May 2010

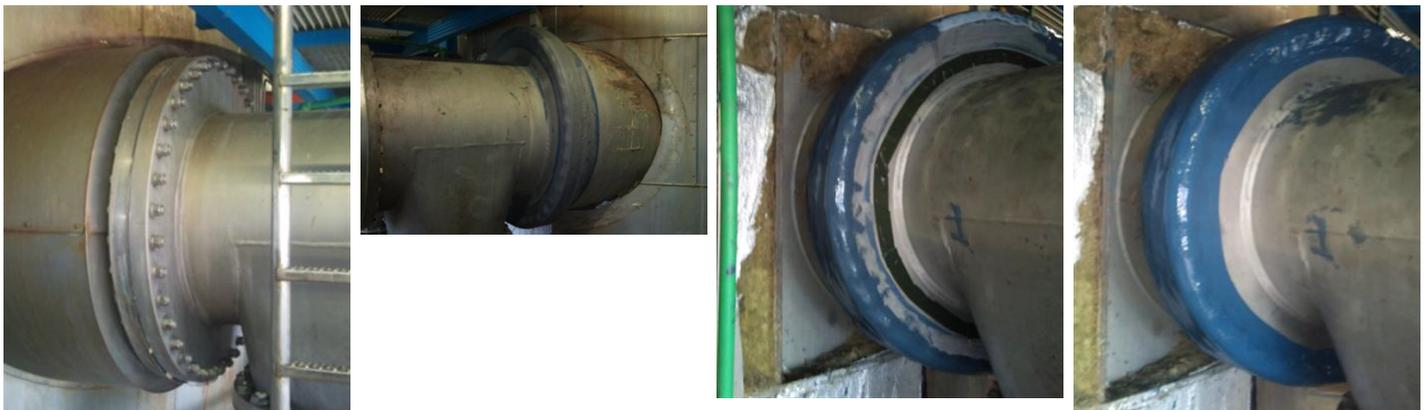
The leaking flange had to be sealed without dismantling as production could not be interrupted.

- \* Leaking flange ,
- \* Application of first coat ,
- \* Application of second coat ,
- \* Complete application ,

Large leaking flange

Application was carried out in accordance with an adapted version of Belzona Know-How System Leaflet VPF-11. After grit blasting, the nuts and bolts were encapsulated with Belzona® 1111 before Belzona® 1391 was applied by brush, incorporating Reinforcement Tape, to completely seal the circumference of the flange joint.

The application was completed in two days and has created a heat resistant seal without having to dismantle the flange. This ensured minimal disruption to production.
