BELZONA REPAIR ON STEEL MILL

ID: 2786

Customer Location: Steel mill, Spain
Application Date: 2009

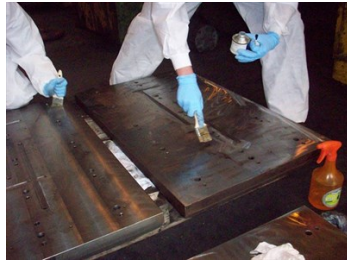
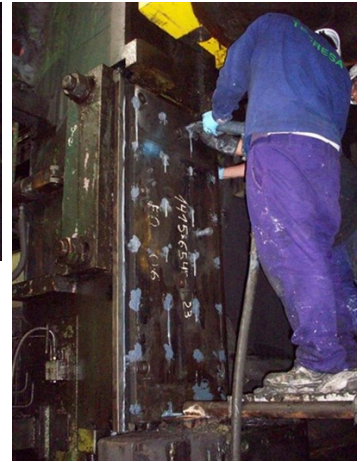
In the rolling mill housing there were several wear plates which guide the hot steel slabs. Impact and vibration from the heavy metal slabs create damage to the housing behind the wear plates. A significant gap occurred between the support and plates leading to misalignment.

- * Mill Housings ,
- * Applying Release Agent to underside of wear plates ,
- * Injection Holes ,
- * Finishing off the injection of Belzona® 1321 ,

Due to impact, the soft steel behind the steel guide wear plates in the steel production line were damaged.

Application carried out in accordance with Belzona Know-How System Leaflet GSS-9. After cleaning and treating the wear plates with Belzona® 9411 (Release Agent), the plates were aligned by experts before the Belzona® 1321 was injected to fill void between wear plate and housing.

Before the repair with Belzona, a new stainless steel plate had to be installed every month. After the Belzona repair, no movement has been detected in the repaired housing after 5 months and the wear plates were still in their ideal position. The mill's downtime has been dramatically reduced.
