BELZONA REPAIR ON STEEL MILL

Customer Location: Steel mill, Spain
Application Date: 2009

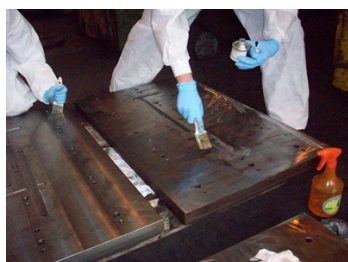
In the rolling mill housing there were several wear plates which guide the hot steel slabs. Impact and vibration from the heavy metal slabs create damage to the housing behind the wear plates. A significant gap occurred between the support and plates leading to misalignment.

- * Mill Housings ,
- * Applying Release Agent to underside of wear plates ,
- * Injection Holes ,
- * Finishing off the injection of Belzona® 1321 ,

Application carried out in accordance with Belzona Know-How System Leaflet GSS-9. After cleaning and treating the wear plates with Belzona® 9411 (Release Agent), the plates were aligned by experts before the Belzona® 1321 was injected to fill void between wear plate and housing.
