BELZONA EXTENDS SERVICE LIFE OF THIS VERTICAL PIVOT BEARING HOUSING

ID: 282

Industry: *Mining & Quarrying*
Application: *MPT-Mechanical Power Transmission*

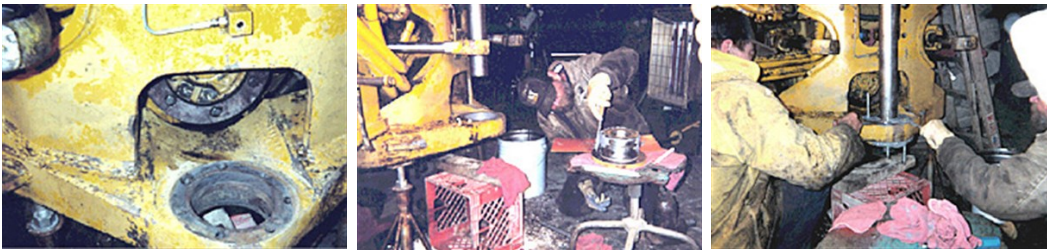
Photograph Descriptions

Ordinary wear and tear eventually enlarges the housing and causes play in the body pivot pin during use.

* Damage evident around pin Application in progress New bushing aligned and installed ,

The application was carried out in accordance with Belzona Know-How System Leaflet MPT-7. Belzona® 1111 (Super Metal) was applied to both the outer bearing race as well as the housing. The bearing is then pressed into the housing and aligned.

This application was completed without costly welding and line boring.
