# BELZONA EXTENDS SERVICE LIFE OF THIS VERTICAL PIVOT BEARING HOUSING

ID: 282

Vertical pivot bearing housing on a piece of heavy equipment.

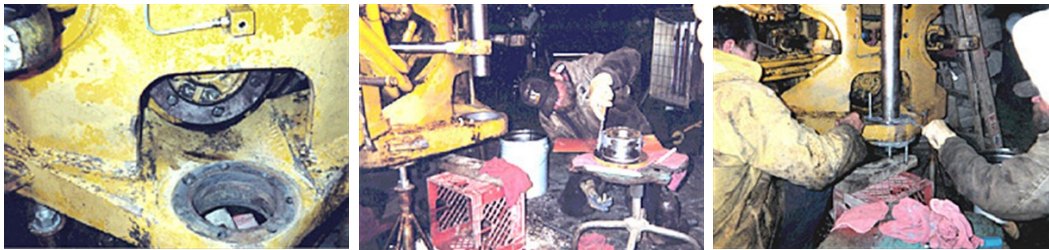
*Ordinary wear and tear eventually enlarges the housing and causes play in the body pivot pin during use.*

\* Damage evident around pin Application in progress New bushing aligned and installed ,

The application was carried out in accordance with Belzona Know-How System Leaflet MPT-7. Belzona® 1111 (Super Metal) was applied to both the outer bearing race as well as the housing. The bearing is then pressed into the housing and aligned.
