BELZONA CORRECTS OVERSIZED KEYWAY

Industry: *Pulp & Paper*
Application: *MPT-Mechanical Power Transmission*

Customer Location: *Paper Mill in Washington State U.S.A.*
Application Date: *Summer of 1988*

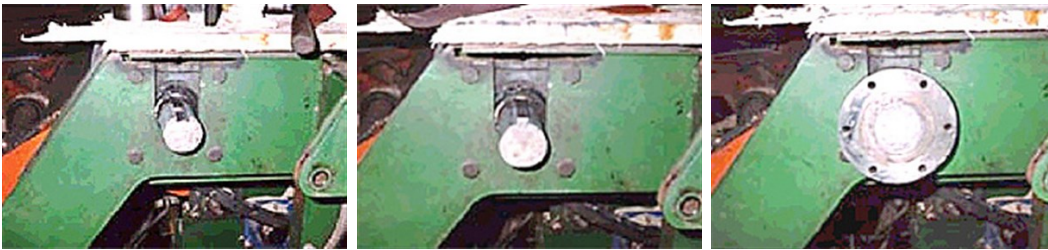
Photograph Descriptions

This lumber decker keyway takes a tremendous beating because of cyclic loading. Because of the start-stop characteristics, the keyway housing became oversized.

- * The equipment prior to the application ,
- * The keyway has been repaired ,
- * The material has cured and the equipment is ready for service ,

The application was carried out in accordance with Belzona Know-How System Leaflet MPT-4. This repair was done in place without disassembly using a Belzona forming technique.
