# BELZONA CORRECTS OVERSIZED KEYWAY

ID: 283

Industry: *Pulp & Paper*  
Application: *MPT-Mechanical Power Transmission*

Customer Location: *Paper Mill in Washington State U.S.A.*  
Application Date: *Summer of 1988*

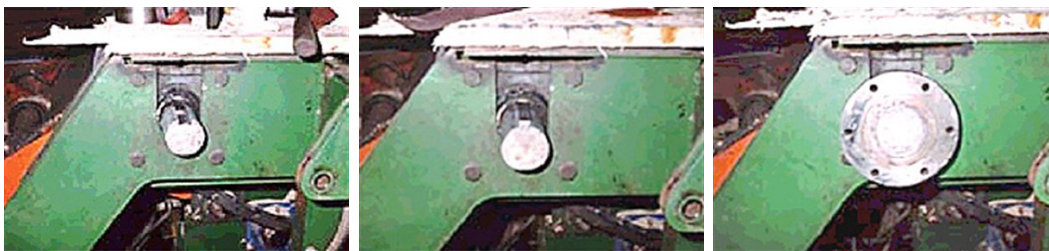
*This lumber decker keyway takes a tremendous beating because of cyclic loading. Because of the start-stop characteristics, the keyway housing became oversized.*

- \* The equipment prior to the application ,
- \* The keyway has been repaired ,
- \* The material has cured and the equipment is ready for service ,

The application was carried out in accordance with Belzona Know-How System Leaflet MPT-4. This repair was done in place without disassembly using a Belzona forming technique.
