BELZONA KEEPS THIS SPLINE ON THE STRAIGHT AND NARROW

Application: MPT-Mechanical Power Transmission

Customer Location: Steel manufacturer in USA

Planetary gear spline for mandril mill manufacturing pipe.

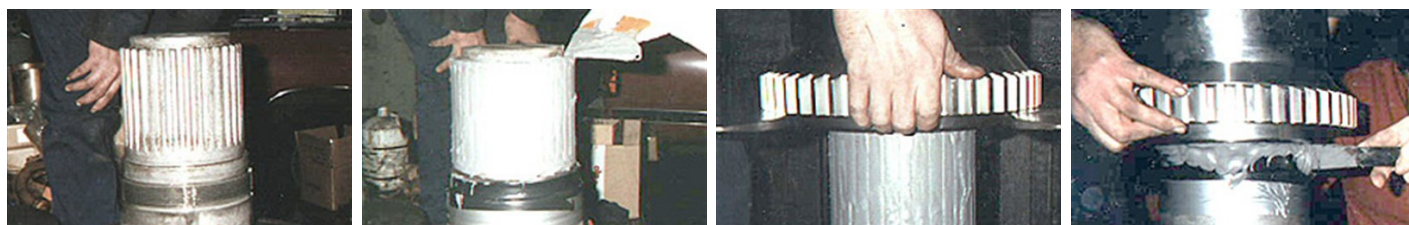
Photograph Descriptions

Wear of the shaft spline due to abrasive contamination as well as misalignment caused excess slop in the drive and eventual failure of the mandril unit.

- * The equipment prior to the application ,
- * Belzona® 1111 is being applied to the spline ,
- * The spline and socket are being mated ,
- * Excess material is being removed ,

The application was carried out in accordance with Belzona Know-How System Leaflet MPT-5. Belzona® 9411 (Release Agent) was applied to the socket and Belzona® 1111 (Super Metal) was applied to both the socket and spline before mating the two pieces.

The spline was in perfect condition 5 years later when the mill finally decided to replace the spline coupling.
