BELZONA NON-SKID SYSTEM REMOVES SLIP AND FALL HAZARD

ID: 289

Customer Location: Hospital in British Columbia, Canada
Application Date: 1997

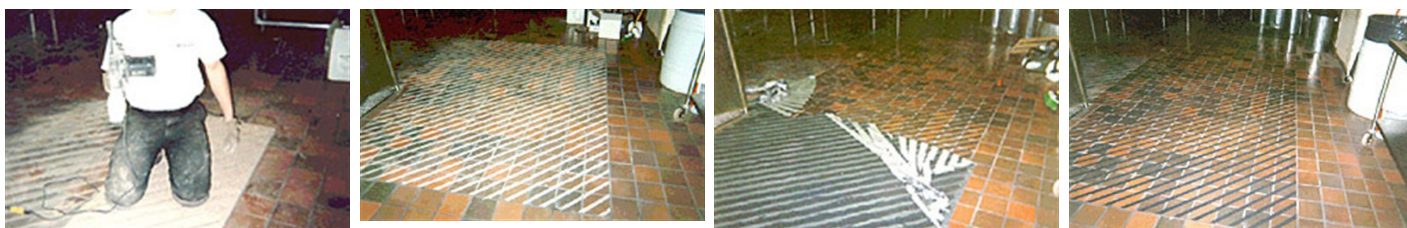
Photograph Descriptions

The floor was plagued with constant complaints arising from slippery floor tiles. Non-skid tape safety pads were in use in strategic areas, but were constantly delaminating from the wet environment and harsh cleaning chemicals.

- * Surface preparation with template ,
- * Glaze removed from quarry tile floor ,
- * Masking tape removed after the application is complete ,
- * Completed application of grip system ,

Quarry tiled floor in a hospital dish washing area.

The application was carried out in accordance with Belzona Know-How System Leaflet FPA-8.

It was found that the Belzona system initially cost about 30% more, but eliminated the need for replacement pads. The application has been in service for 5 years with no required maintenance.
