BELZONA REPAIRS WATER JET FLANGE AREA

ID: 2930

Customer Location: Naval shipyard, Vaxholm, Sweden
Application Date: December 2011

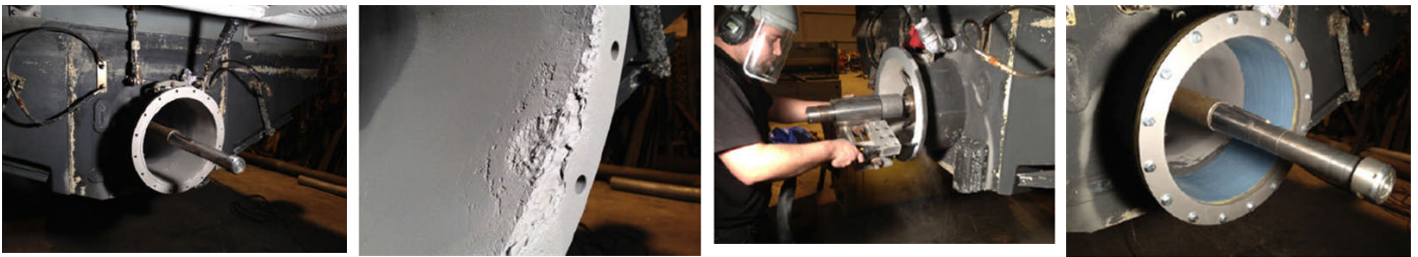
The water jet tunnel was suffering from cavitation and corrosion the flange holding the impeller housing in place. The most severe damages were found on the flange face and extended 20 cm inwards. Additionally the flange face was found to be distorted.

- * The damaged water jet unit ,
- * A close-up of the damage ,
- * Machining down the flange surface after rebuilding with Belzona® 1111 ,
- * completed application after coating with Belzona® 1341 ,

Application was carried out in accordance with Belzona Know-How system Leaflets VPF-1 & 2. Flange face and cavitation erosion was rebuilt with Belzona® 1111. critical clearances were machined before applying Belzona® 1341 for overall erosion corrosion protection.
