BELZONA REPAIRS DAMAGED FIRE ESCAPE STEPS AT SCHOOL

Steel fire escape steps

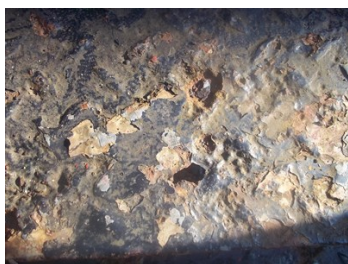
Due to age and weathering the steel plates had become holed and badly corroded creating a safety hazard.

- * Corroded & holed steps ,
- * Surface preparation ,
- * Holed steps repaired with Belzona® 1111 ,
- * Completed steps with Belzona® 5811 applied and nosings blinded with Surefoot Aggregate ,
