BELZONA REPAIRS DAMAGED FIRE ESCAPE STEPS AT SCHOOL

ID: 2933

Steel fire escape steps

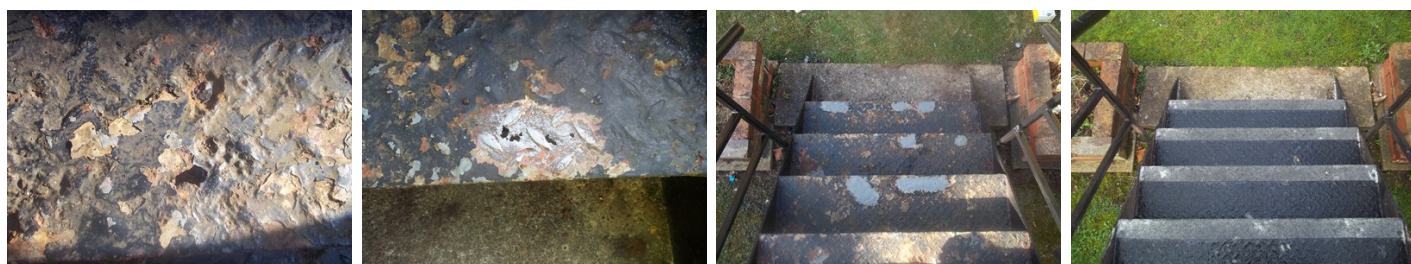
Photograph Descriptions

Due to age and weathering the steel plates had become holed and badly corroded creating a safety hazard.

- * Corroded & holed steps ,
- * Surface preparation ,
- * Holed steps repaired with Belzona® 1111 ,
- * Completed steps with Belzona® 5811 applied and nosings blinded with Surefoot Aggregate ,

Application was carried out in accordance with Belzona Know-How System Leaflet FPA-8. After surface preparation was carried out, the small holed areas were rebuilt with Belzona® 1111. The steps were then overcoated with Belzona® 5811 and Belzona® 9221 (Surefoot Aggregate) blinded into the step noses.
