# BELZONA TAKES OFF AT THIS INTERNATIONAL AIRPORT

ID: 294

**Industry:** General Industry  
**Application:** FPA-Floor Problem Areas  
**Substrate:** Steel reinforced concrete.  
**Products:** \* Belzona® 4111 (Magma Quartz) ,

**Customer Location:** International Airport, U.S.A.  
**Application Date:** 1993

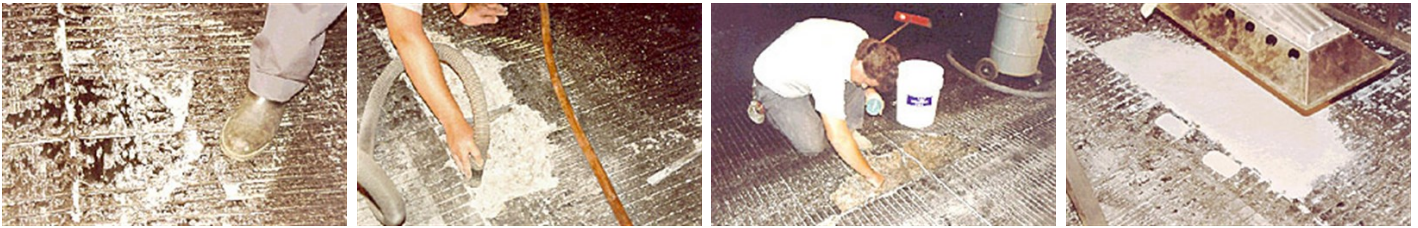
Certain sections of the runway and ramps were spalled from both thermal cycling as well as mechanical damage from constant aircraft traffic.

- \* Spalled concrete on runway ,
- \* Surface prepared by chipping loose concrete ,
- \* Conditioned with Belzona® 4911 (Magma TX Conditioner) ,
- \* Curing of completed repair being accelerated with heat ,

Belzona® 4111 (Magma Quartz) was mechanically mixed after the damaged areas were prepared and thoroughly conditioned. The repair material was hand applied and accelerated with infrared lighting to sufficiently cure in the scheduled four-hour downtime. Nine other repair materials were tried, but all failed because of a combination of slow cure times and poor adhesion characteristics.
