BELZONA TAKES OFF AT THIS INTERNATIONAL AIRPORT

ID: 294

Customer Location: International Airport, U.S.A.
Application Date: 1993

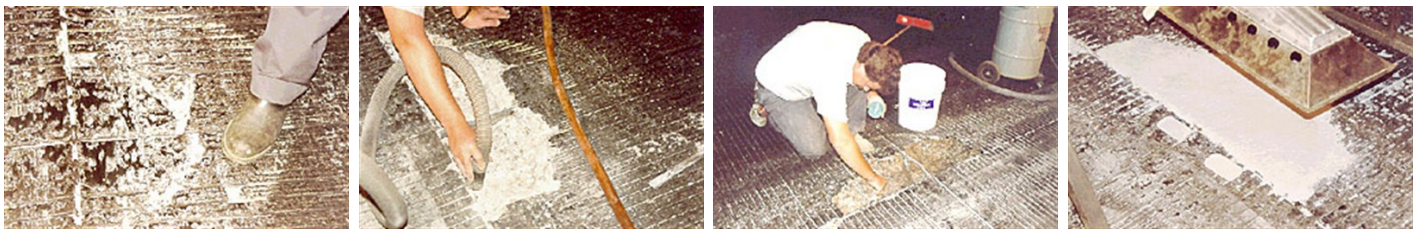
Photograph Descriptions

Certain sections of the runway and ramps were spalled from both thermal cycling as well as mechanical damage from constant aircraft traffic.

- * Spalled concrete on runway ,
- * Surface prepared by chipping loose concrete ,
- * Conditioned with Belzona® 4911 (Magma TX Conditioner) ,
- * Curing of completed repair being accelerated with heat ,

Belzona® 4111 (Magma Quartz) was mechanically mixed after the damaged areas were prepared and thoroughly conditioned. The repair material was hand applied and accelerated with infrared lighting to sufficiently cure in the scheduled four-hour downtime. Nine other repair materials were tried, but all failed because of a combination of slow cure times and poor adhesion characteristics.
