# BELZONA RESTORES CONCRETE FLOOR

ID: 295

**Customer Location:** Manufacturing facility in Columbus, Ohio U.S.A.

**Application:** FPA-Floor Problem Areas

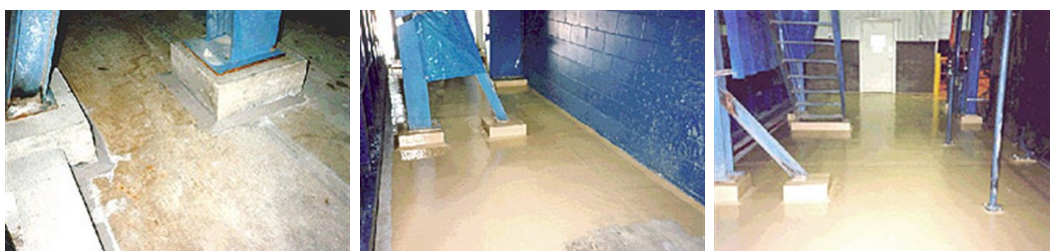
## Photograph Descriptions

The concrete floor was beginning to show signs of degradation in the wash down area. The entire facility has a rubber liner underneath to protect from ground water contamination.

- \* Cracks and penetrations rebuilt with Belzona® 4111 (Magma Quartz) ,
- \* First coat of Belzona® 5811 (Immersion Grade) ,
- \* The application is complete ,

The Belzona® 4111 (Magma Quartz) was used to rebuild the cracks in the concrete and tie in the penetrations through the floor. After the initial cure, Belzona® 5811 (Immersion Grade) was then used to seal the surface with two coats of beige. There are also many ground water inspection ports throughout, and the floor showed signs of deterioration after its first few years of operation, which is why they turned to Belzona.
