BELZONA REPAIRS DAMAGED CONCRETE AT CIDER PLANT

ID: 2955

Customer Location: *Cider producer, Herefordshire, UK*

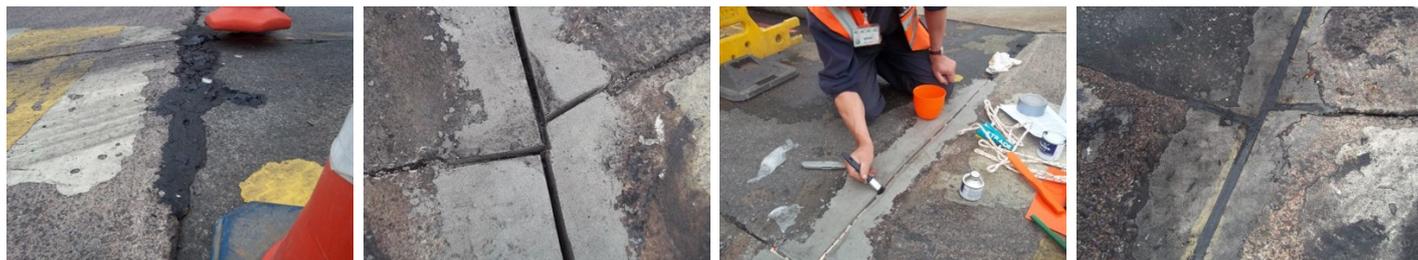
Photograph Descriptions

Damaged concrete on walkway was identified as a trip hazard.

* Previous attempted repair Nosings rebuilt with Belzona® 4131 Application of Belzona Elastomer Conditioner Completed application with joint sealed using Belzona® 2211 ,

Application was carried out in accordance with Belzona Know-How System Leaflet FPA-5 & 6. Damaged joint nosings were reformed with Belzona® 4131 before sealing joint with Belzona® 2211.

Other cheaper products had been used to try and fix problem but with no success. Belzona was chosen due to its proven reliability and longevity at other applications around the site. Belzona 4131 provides an impact resistant joint nosing whilst Belzona® 2211 provides strongly bonded highly elastic joint sealant.
