# BELZONA FREEZES EXPANSION JOINT DAMAGE

ID: 296

**Customer Location:** Food supplier in North Carolina, U.S.A.  
**Application Date:** 1990

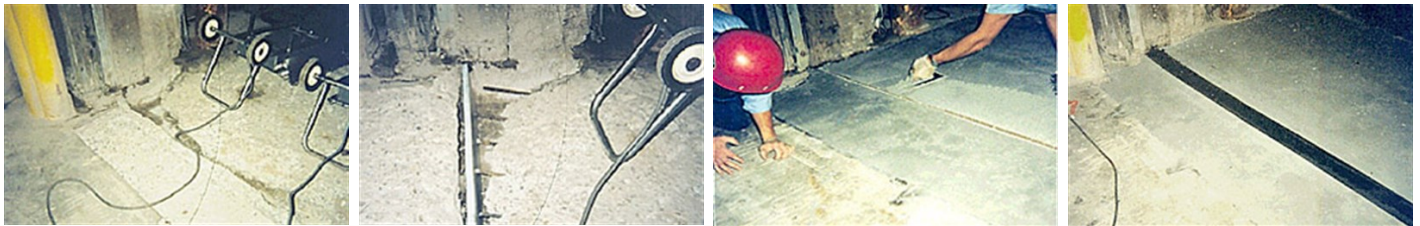
*The expansion joint on the floor leading into the freezer was completely destroyed by continuous fork lift traffic as well as the freeze/thaw cycles at the frost line.*

- \* Significant damage to expansion joint at freezer entrance ,
- \* Deteriorated concrete removed exposing rebar ,
- \* Screeding in Belzona® 4131 (Magma Screed) ,
- \* Belzona® 2211 used to seal the joint ,

The application was carried out in accordance with Belzona Know-How System Leaflets FPA-5 and FPA-6.

Freeze/thaw effects are very damaging to concrete and the repair material used must be able to cure in cold temperatures and still maintain significant adhesion to the existing substrate.
