# BELZONA REBUILDS MOUNTING SURFACE OF BALL MILL JOURNAL

ID: 2961

Customer Location: Cement Plant, Bulgaria

Application Date: November, 2011

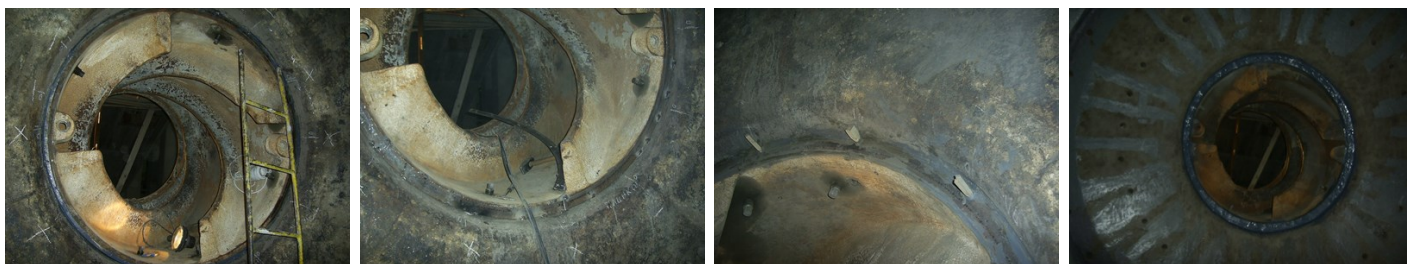
Ingress of lime particles and water caused severe wear between feed screw insert and ball mill journal. The diameter is 1500mm and length 200mm.

- \* Sealing the inner joint ,
- \* Sealing the outer border with metal ring. Injection ports were drilled in the ring ,
- \* Rebuilding of the mounting surface by injection of Belzona® 1321 ,
- \* Completed application with Belzona® 1812 applied at the frontal interface between ball mill journal and screw insert ,

Application was carried out in accordance with Belzona Know-How Leaflet GSS-9. Belzona 1321 was injected into annular gap between new screw insert and ball mill journal. After that Belzona 1812 was applied at the frontal interface between insert and journal to prevent further abrasion from lime particles.

Previous repairs by welding and machining of the mounting surface were not successful due to problems with machining and centralising the insert. As a consequence the significant movement and vibration caused the mounting surface to wear quickly and the ingress of the ground lime particles further increased abrasion. The Belzona solution allowed the mounting surface to be rebuilt with zero deviation using the new screw insert as former after its alignment in the journal. The heavy movement and vibration was
