# BELZONA RESTORES PROFILE OF BALL MILL

ID: 2970

Ball Mill for grinding limestone in cement production

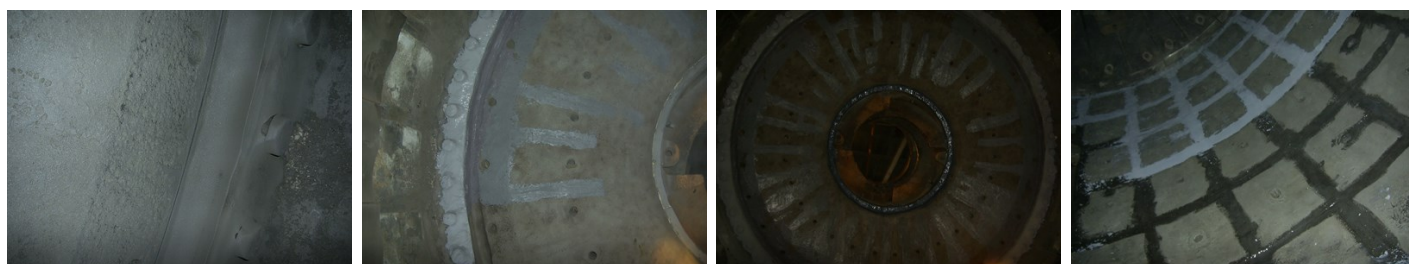
## Photograph Descriptions

Severe wear particularly on the front wall and feed tube into the main shell.

- \* View of severe abrasion damages were clearly evident after dismantling the tiles and blasting the surface ,
- \* Application in progress ,
- \* Completed application of the front wall ,
- \* Additionally application of Belzona® 4111 system to restore the profile of the shell ,

Application was carried out in accordance with modified version of the Belzona Know-How System Leaflet SHM-7. Belzona® 4111 was applied around connecting bolts on the front wall and the shell. Belzona® 1812 was used to restore profiles lost through severe erosion. Belzona® 1121 was used for smoothing the areas with small pitting and erosion damages. These applications were carried out before re-fitting the wear resistant tile lining.
