# HOSPITAL KITCHEN REPAIRED WITH BELZONA

**Industry:** General Industry  
**Application:** FPA-Floor Problem Areas  
**Substrate:** Quarry tile and concrete  
**Products:** \* Belzona® 4131 (Magma Screed) ,  
\* Belzona® 2211 (MP Hi-Build) ,  
\* Belzona® 4151 (Magma Quartz Resins) ,

**Customer Location:** Hospital in North Carolina, U.S.A.  
**Application Date:** Winter 2000

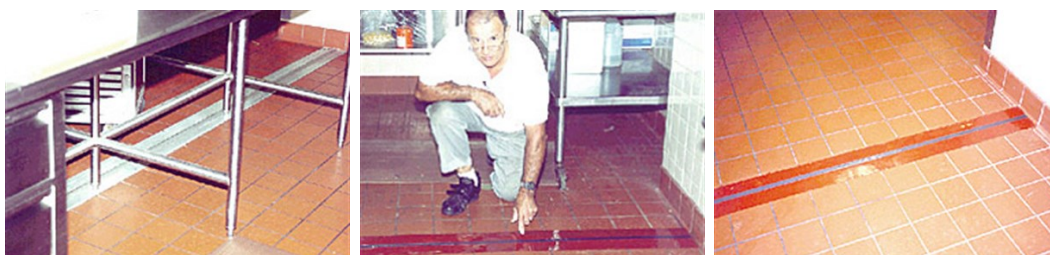
## Photograph Descriptions

The metal expansion joint in the kitchen of this hospital had failed and the deterioration caused interruption in cart movement over the irregular sur-face.

- \* Damaged metal expansion joint ,
- \* Finished application with Belzona® 4151 recently applied ,
- \* Nosing fully cured and ready for traffic ,

Metal expansion joint or slip joint in hospital kitchen floor.

The application was carried out in accordance with Belzona Know-How System Leaflets FPA-5 and FPA-6.

The red Belzona® 4131 (Magma Screed) gives the repair area a close color match to the original quarry tile floor.
