# BELZONA KEEPS WATER SAFE TO DRINK

**Industry:** Water / Wastewater  
**Application:** FPA-Floor Problem Areas  
**Substrate:** Concrete  
**Products:** \* Belzona® 4111 (Magma Quartz) ,  
\* Belzona® 3121 (MR7) ,  
\* Belzona® 4151 (Magma Quartz Resins) ,

**Customer Location:** Regional Water Authority in England  
**Application Date:** November 1992

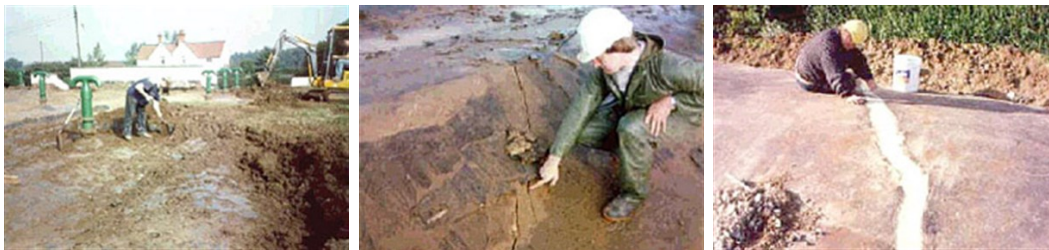
Cracks in the roof of the storage tank were allowing the ingress of surface water and contaminating the potable water contained in the reservoir. This leads to unacceptably high levels of nitrate, phosphate and miscellaneous contaminants in the tank.

- \* Excavating underground storage tank ,
- \* Crack through roof of tank ,
- \* Repaired with Belzona® 4111 (Magma Quartz) ,

Underground concrete water storage tank.

The application was carried out in accordance with Belzona Know-How System Leaflet FPA-1.

Butyl rubber sheeting bonded with bitumen had been ineffective in sealing the roof.
