# BELZONA FOR MUD PUMPS

Customer Location: Offshore oil drilling platform in the Gulf of Mexico.

Application: CEP-Centrifugal Pumps

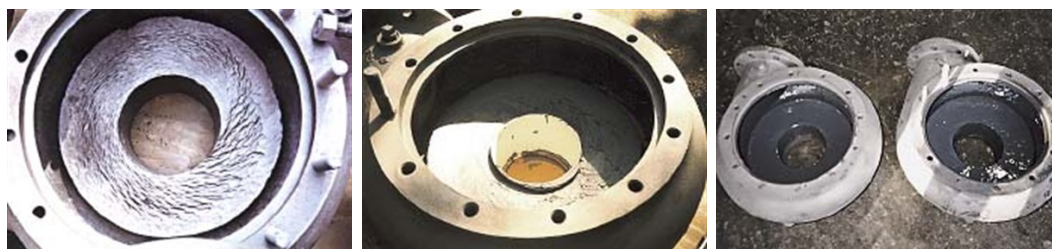
Severe erosion.

- \* Severe wear on the pump casing. ,
- \* Forming technique and Belzona® 1311 (Ceramic R-Metal) used to rebuild the intake. ,
- \* Two coats of Belzona® 1321 (Ceramic S-Metal) applied. Several pumps have been refurbished. ,

Mud pumps, casings and wear plates.

The application was carried out in accordance with Belzona Know-How Leaflets CEP-3 and CEP-5.

The use of Belzona doubled the life of the casing and saved the replacement costs. Originally, the equipment lasted 3 months before being discarded and now it lasts 6 months and can be refurbished again and again.
