# BELZONA REPAIRS CROSS THREADED FITTINGS WITHOUT MACHINING

ID: 300

Industry: *Pulp & Paper*  
Application: *ENC-Engines and Casings*  
Substrate: *Steel*  
Products: *\* Belzona® 1111 (Super Metal) ,*

Customer Location: *Austrian paper mill*  
Application Date: *April 1992*

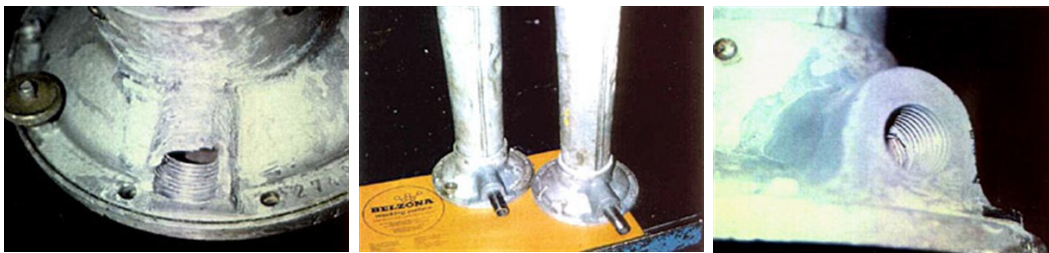
*Operator error in cross threading the inlet fittings in the casing of two steel venturi eductor nozzles damaged the units and were unable to function properly.*

- \* View of damaged venturi casing ,
- \* View of eductor nozzles during forming process ,
- \* Completely reformed threads ,

Belzona® 9411 (Release Agent) was applied to the male threaded fitting and allowed to dry for at least 20 minutes. Belzona® 1111 (Super Metal) was then applied to the threads of both the male and female components and brought together immediately. Following full cure, the fittings were removed to reveal perfectly reformed threads without machining.
