# BELZONA REPAIRS CORRODED GAS PIPE AT BOILER HOUSE

**Customer Location:** University, Manchester UK  
**Application Date:** February 2012

Main gas feed pipe to boiler house at large University building.

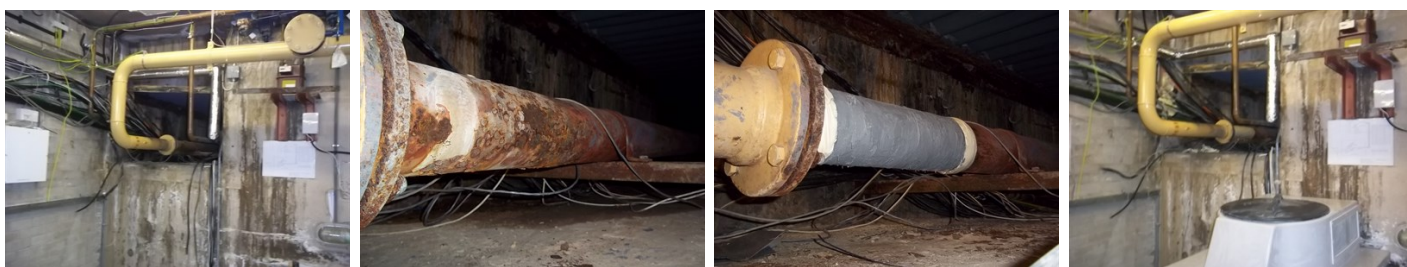
## Photograph Descriptions

*Following asbestos removal several years ago, a section of a gas main pipe had been left exposed to water ingress from above and as a result had suffered corrosion and metal loss. The client required a solution that was quick, easy and safe to apply to a live gas pipe, that would replace the metal loss and provide lasting protection from further corrosive attack.*

- \* The entry point of the Gas pipe via a service tunnel making access and application difficult ,
- \* Close up of corroded section of pipe ,
- \* Completion of Belzona® 1161 application ,
- \* Completion of application including final coat of Belzona® 5831 ,

The application was carried out in accordance with a modified version of Belzona Know-How System Leaflet VPF-11. Belzona® 1161 was applied to rebuild and protect the badly corroded section of the pipe followed by a heavy coat of Belzona® 5831 for added corrosion protection.
