BELZONA SAVES THIS BULL GEAR FOR A SECOND TIME

ID: 303

Bull gear and spline for 100-ton overhead crane.

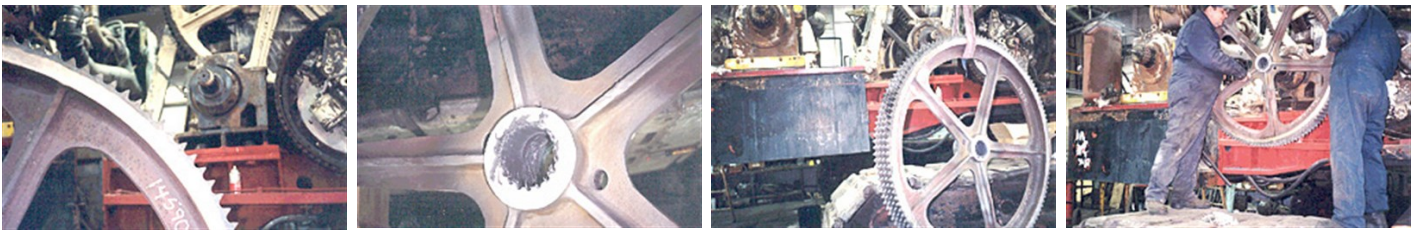
Photograph Descriptions

12-years prior, the assembly was rebuilt with Belzona® 1111 (Super Metal) which needed refurbishment. Excess play in the spline made it difficult for precision movements.

- * Damage bull gear spline ,
- * Belzona® 1311 (Ceramic R-Metal) applied to socket ,
- * Lifting gear into position ,
- * Aligning bull gear onto spline ,

Both the male spline and the female socket of the bull gear were blasted. Belzona® 9411 (Release Agent) was applied to the spline and Belzona® 1311 (Ceramic R-Metal) was applied to both, subse-quentially mated, aligned and indexed. There is really no affordable alternative for this 35-year old bull gear. It would have to be custom fabricated, which is both time consuming and costly.
