BELZONA REPAIRS DAMAGED CONCRETE IN PRIMARY SCHOOL PLAYGROUND

ID: 3032

Industry: *Buildings & Structures*
Application: *FPA-Floor Problem Areas*
Substrate: *Concrete / Cement*
Products: ** Belzona® 4131 (Magma Screed) ,*

Customer Location: *Derbyshire UK*
Application Date: *December 2009*

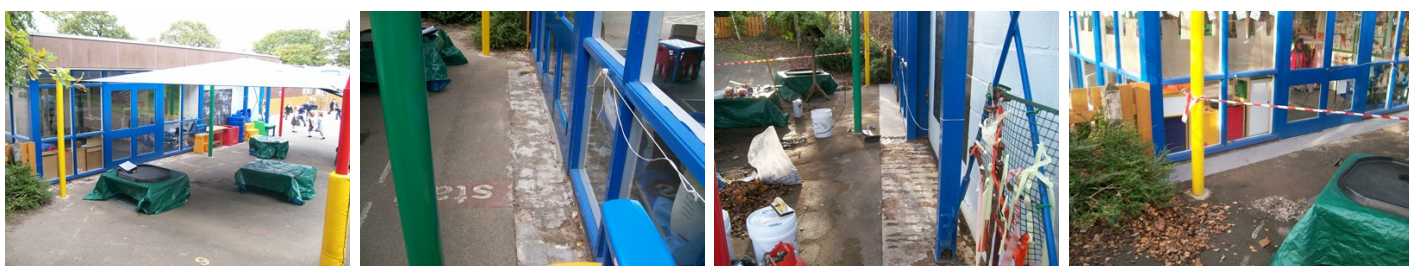
Photograph Descriptions

Some loose and damaged tiles had been removed in the playground bordering a class room. This had left concrete exposed and the area looking unsightly and representing a potential slip/trip issue for young children.

- * The school play/activity area ,
- * The damaged area to be repaired ,
- * Belzona® 4131 repair in progress ,
- * Completed application ,

The application was carried out in accordance with Belzona Know-How System Leaflet FPA-1

School required a quick and permanent solution to the issue. Traditional concrete/cement solutions were not appropriate as the bond strength would not be sufficient and it would be likely to shrink and crack creating additional problems. Hot work was out of the question and any products that would leave oily residue that could contaminate the children and their clothes were also not acceptable. Belzona® 4131 was chosen for its high bond strength, quick cure, high abrasion and impact resistance. Its ability to be

feather edged ensured it was flush with adjacent areas to the repair. The work was completed in one day and to the complete satisfaction of the school who asked us to return to repair a similar problem in another area of the playground.
