BELZONA INJECTS NEW LIFE INTO HYDRO DAM BEARING

ID: 3089

Industry: Power
Application: MPT-Mechanical Power Transmission

Customer Location: Hydroelectric plant, Missouri
Application Date: February 2012

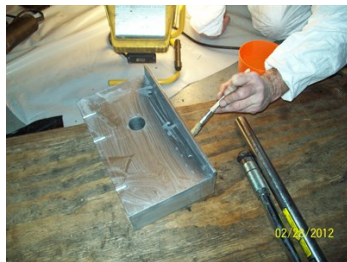
While running a high voltage test on the bearing and isolator ring a section of the bearing was damaged when a spark melted one area.

- * Close up of the damaged surface ,
- * Mold being treated with release agent ,
- * Injecting the Belzona® 1321 ,
- * Completed repair ,

The application was carried out using a modified version of Belzona Know-How System Leaflet MPT-2. The Belzona® 1321 was injected into a mold that had been treated with Belzona® 9411 (Release agent) after the Belzona® 1221 had been used to seal all the open areas to contain the injected material within the repair area.
