BELZONA RECLAIMS A SHAFT AFTER A BEARING FAILURE DAMAGED BOTH ENDS

ID: 309

Customer Location: *Abitibi Price Paper Mill in Ontario, Canada*

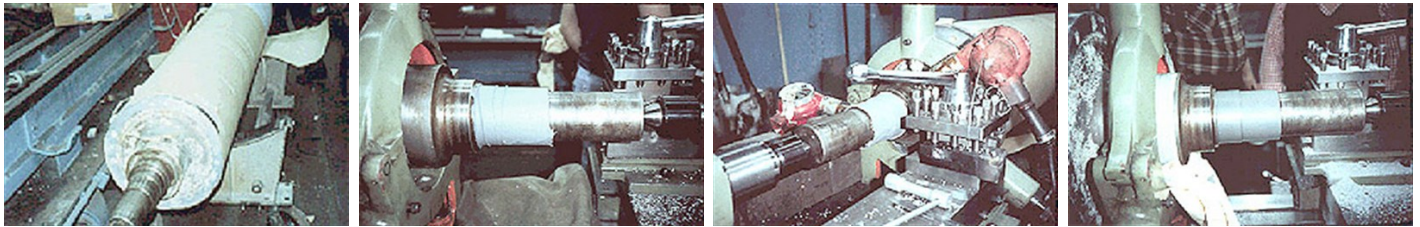
Photograph Descriptions

A hydraulic press on either end of an embossing roller is used to control appropriate operating pressure, caused premature bearing failure, damaging both ends of the shaft.

- * Scored shaft of an embossing roller ,
- * Application of Belzona® 1111 (Super Metal) ,
- * Accelerating the cure using a heat gun ,
- * Rebuilt bearing surface and shoulder using lathe ,

The application was carried out in accordance with Belzona Know-How System Leaflet MPT-1.

This is a good illustration of proper machining techniques as well as acceleration of cure using heat guns placed at the appropriate distance from the shaft. The shaft must be cooled down before final machining to maintain tolerances.
