BELZONA PROTECTS WASTE WATER TANK ON FERRY

ID: 3096

Waste water tank on a passenger ferry operating between Sweden and Finland.

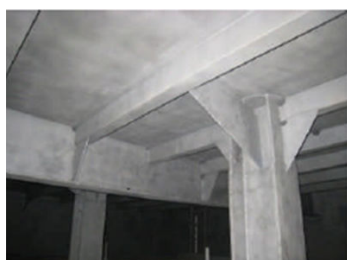
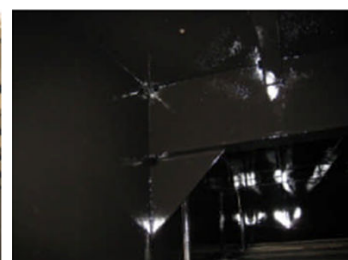
The corrosion was due to fermentation of sanitary and food waste. The previous corrosion protective system was based on Vinyl ester and had become loose and failed.

* Passenger ferry Tank internals grit blasted First coat in beige colour had been spray applied and stripe coating of details with black carried out The final result after application of the second coat of Belzona® 5811 ,

Application was carried out in accordance with Belzona Know-How System Leaflet TCC-5. Fillets and edges were coated by hand application before the whole area was coated with two coats of 5811 by airless spray application.
