BELZONA RESTORES HUGE DYNAMOMETER

ID: 3116

Application: CEP-Centrifugal Pumps

Customer Location: Marine Engine Manufacturer, Croatia

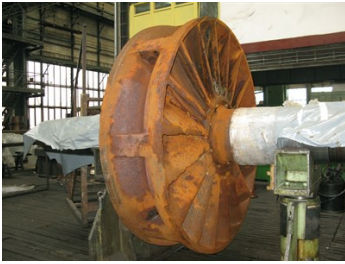
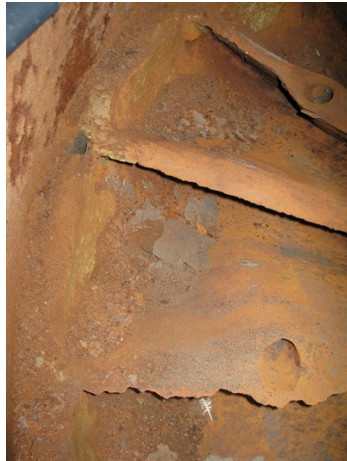
Long years in service and chloride attack degraded the surface profile of the dynamometer.

* Impeller Casing clearly showing degree of erosion present Protected impeller Protected casing ,

Application was carried out in accordance with Belzona Know-How System Leaflets CEP-1, CEP-3 and CEP-5. After the profile of the impeller and the casing had been rebuilt with Belzona® 1121, the whole dynamometer was protected with Belzona 5811. Finally Belzona® 1321 was used for extra protection for the casing and impeller blades.
