BELZONA RESTORES HUGE DYNAMOMETER

Customer Location: Marine Engine Manufacturer, Croatia

Application: CEP-Centrifugal Pumps

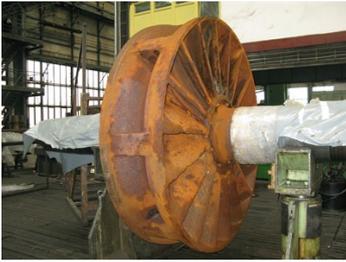
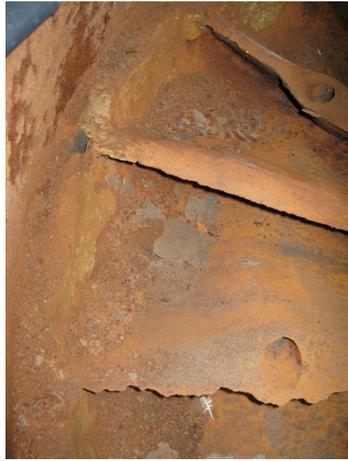
Long years in service and chloride attack degraded the surface profile of the dynamometer.

* Impeller Casing clearly showing degree of erosion present Protected impeller Protected casing ,

Application was carried out in accordance with Belzona Know-How System Leaflets CEP-1, CEP-3 and CEP-5. After the profile of the impeller and the casing had been rebuilt with Belzona® 1121, the whole dynamometer was protected with Belzona 5811. Finally Belzona® 1321 was used for extra protection for the casing and impeller blades.
