# BELZONA GETS HEAVY EQUIPMENT BACK IN SERVICE, FAST!

ID: 312

Scored hydraulic ram for a front end loader.

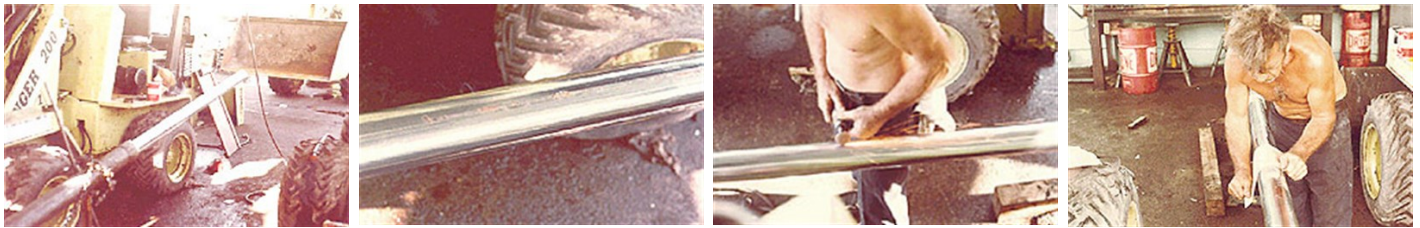
*Small pieces of rock worked their way underneath the seal and scored the hydraulic ram of this front end loader. Since hydraulic pressure was not able to be maintained, this piece of equipment was out of service.*

- \* Damaged hydraulic ram ,
- \* Close-up and extension of cylinder damage ,
- \* Surface preparation with small grinder ,
- \* Dressing down the repair ,

The application was carried out in accordance with Belzona Know-How System Leaflet MPT-3.
