BELZONA RESTORES HEAT EXCHANGERS

ID: 3124

Customer Location: *Hotel, Guaruja, Brazil*
Application Date: *June 2011*

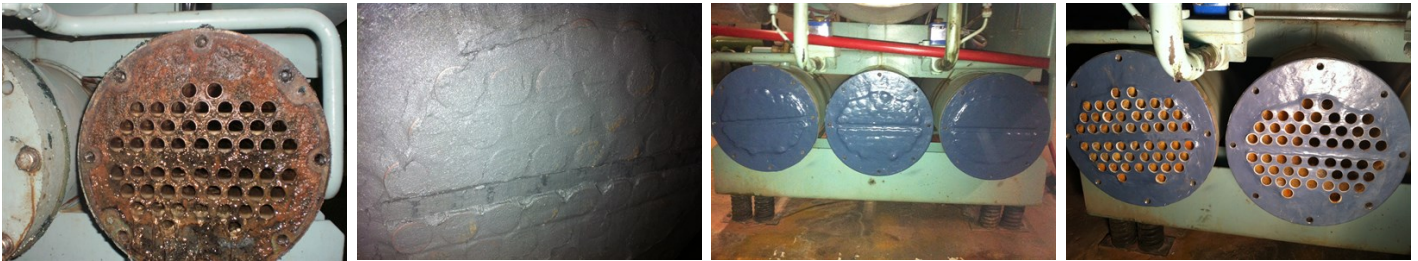
Photograph Descriptions

Severe galvanic corrosion on the flange face and tube sheets of heat exchangers.

- * Corroded tube sheet ,
- * Rebuilding surface with Belzona® 1111 ,
- * Application of Belzona® 1321 ,
- * Final result after removing corks ,

Application was carried out in accordance with Belzona System Leaflets HEX-1 & HEX-3.

In 3 days we were able to solve the customer problem and give a few more years of life to the equipment. The air conditioning plant was refurbished in just three days ensuring minimal disruption to hotel operation. The excellent corrosion protection from the Belzona on will provide many more years service from this plant.
