BELZONA PROTECTS THICKENER FROM CORROSION

Customer Location: Water Treatment Company, Sorocaba, Brazil

Application: TCC-Tanks and Chemical Containment Areas

Drum thickener in waste water treatment process

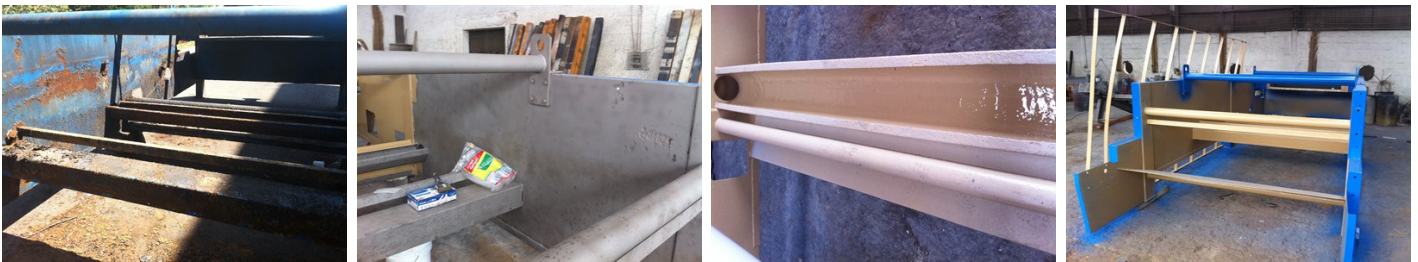
Photograph Descriptions

In just six months of use the equipment was already showing signs of corrosion from corrosion and chemical attack from the waste water sludge

- * Corroded thickener ,
- * Surface washed and grit blasted ,
- * Coating detail items ,
- * Completed application ,

The application was carried out in accordance with Belzona System Leaflet TCC-5. After power washing and grit blasting, a two coat system, of Belzona® 5811 was applied.
