# BELZONA REBUILDS KORT NOZZLE

ID: 3128

Industry: *Marine*  
Application: *SOS-Ships and Offshore Structures*

Customer Location: *Shipping Company, Santos, Brazil*  
Application Date: *December 2011*

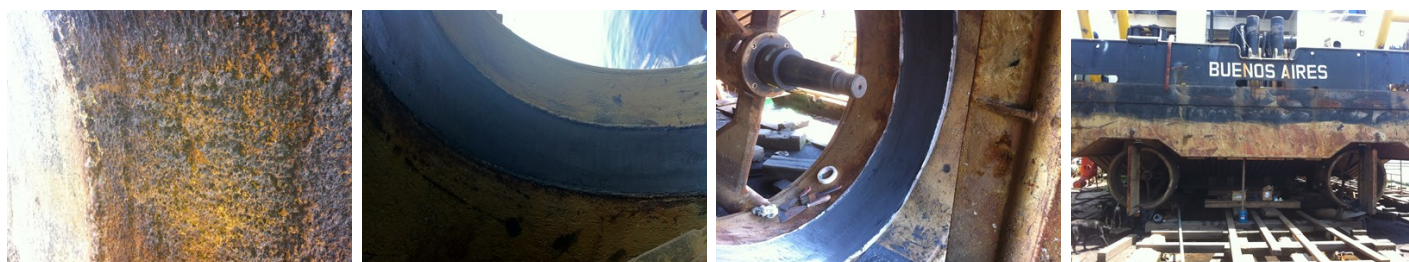
## Photograph Descriptions

- \* Eroded area ,
- \* Belzona® 1311 application ,
- \* Completed Belzona® 1311 application ,
- \* Vessel ready to refloat. ,

Badly corroded kort nozzle

Application was carried out in accordance with Belzona Know-How System Leaflets SOS-1. After grit blasting, Belzona® 1311 was used to rebuild eroded metal and provide future erosion corrosion protection.
