BELZONA CONTAINS 98% SULPHURIC ACID

Industry: Chemical & Petrochemical
Application: TCC-Tanks and Chemical Containment Areas
Substrate: Concrete
Products: * Belzona® 4311 (Magma CR1) ,

Customer Location: Chemical Plant, Porto Feliz, Brazil
Application Date: November 2011

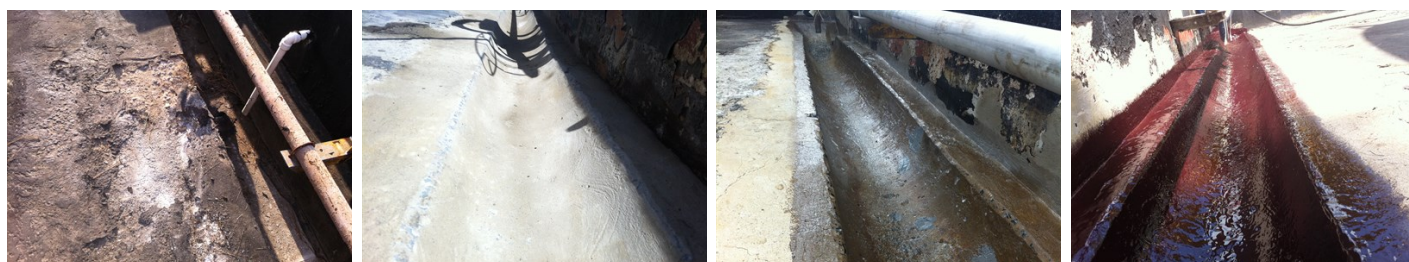
Photograph Descriptions

Previously used coatings had failed allowing the acid to attack the underlying concrete.

- * Failure of previously used coating ,
- * Surface prepared ,
- * Substrate conditioned with Belzona® 4911 ,
- * Finished job ,

Application was carried out in accordance with Belzona Know-How System Leaflet TCC-15. Old coating was removed and damaged concrete rebuilt with new concrete. After drying out for 28 days 2 coat system of Belzona® 4311 was applied.
