# BELZONA PROVIDES LONG TERM PROTECTION FOR THIS TROUGH

Customer Location: *City of Boone Wastewater Treatment Facility, North Carolina, USA*

Application: *TCC-Tanks and Chemical Containment Areas*

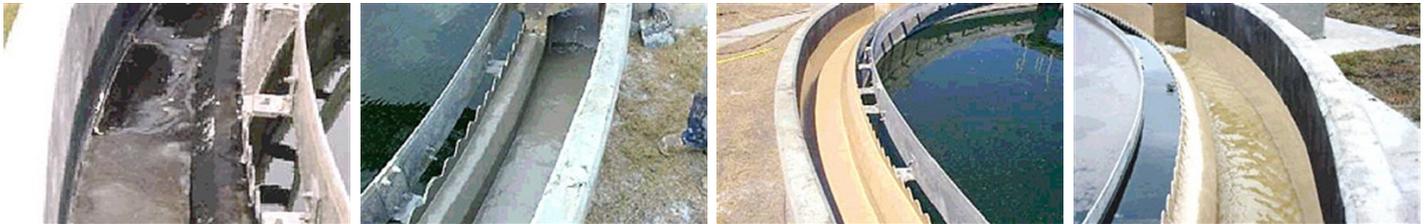
## Photograph Descriptions

*Previous elastomeric coating started to fail and algae built up and made it very difficult to clean. In addition, the concrete behind the lining began to deteriorate, as cracking and spalling of the substrate were evident.*

- \* Previously damaged elastomeric lining ,
- \* Clarifier trough rebuilt with Belzona® 4131 (Magma Screed) ,
- \* Clarifier trough coated with Belzona® 5811 (Immersion Grade) ,
- \* Clarifier back in service. ,

The application was carried out in accordance with Belzona Know-How System Leaflets TCC-9 and TCC-15.
