# Belzona Strengthens Laydown Deck

ID: 3204

Offshore Oil Platform Laydown Deck

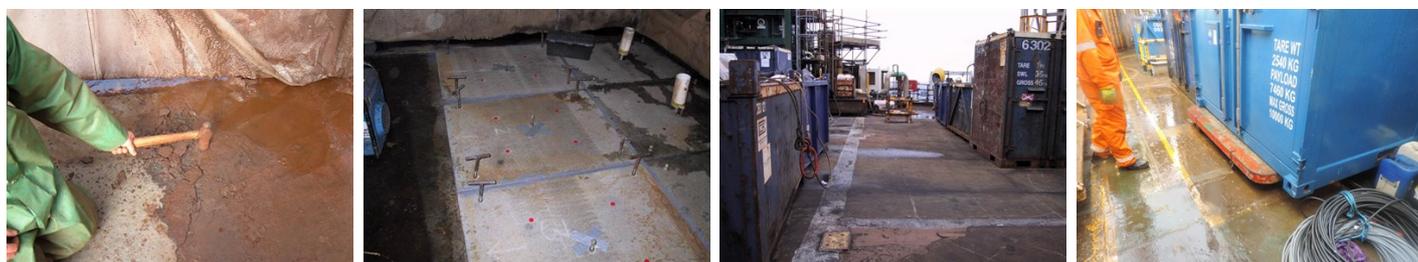
The deck had become weakened through daily operation (lowering/removal of containers) and weather. The original 8mm steel deck was corroded through wall in many locations. welding was not an option due to the installed underr-deck passive fire protection.

- \* Condition of deck prior to starting work ,
- \* Installation of deck reinforcement ,
- \* Completed works ,
- \* Inspection in 2015 ,

A modified version of Belzona System Leaflet GSS-9 was employed. 5mm steel plates, drilled to accept jacking bolts and injection ports, were prepared by gritblasting and positioned onto the gritblasted deck. The jacking bolts were used to obtain accurate levels. The circumference of the plates were sealed using Belzona® 1111. Belzona® 5811 was injected into the void using an airless pump to seal and bond the reinforcement plate to the deck with 100% contact area being achieved.

Independent testing showed that the Belzona bonding method in this case was equivalent in strength to a welded plate, stiffer AND more elastic than the original 8mm plate, good resistance to impact loading, and considered by the independent engineering designers to be "robust enough to withstand the rigours of laydown area operations. The key benefits were that daily operations were not interrupted and that the passive fire protection in the machinery space below would not be affected. This work has been inspected annually and has resulted in other deck strengthening projects being undertaken. Last feedback and inspection image received in 2015, engineers are still delighted with the work.
