# BELZONA RESTORES POTABLE WATER SUPPLY TO CHINESE CITY

**Customer Location:** Municipal concrete water pipeline in  
Guang Dong Province, China

**Application:** VPF-Valves, Pipes and Fittings

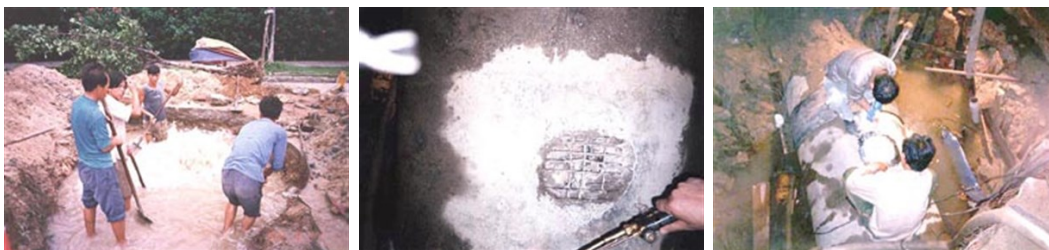
Routine construction above caused physical damage to this 1.2 meter diameter concrete pipeline carrying potable water to Guang Dong Province.

- \* Pipe leaking large volumes of potable water ,
- \* Pipe damage prepared for Belzona repair ,
- \* Repair completed with Belzona® 4111 (Magma Quartz) ,

Water pressure was cut from the line and the damaged area prepared with small grinders to remove the loose concrete and get to the exposed rebar. Belzona® 4211 (Magma Stop) was then used to quickly seal the hole and Belzona® 4111 (Magma Quartz) to reinforce the repair area. After curing the Belzona with external heat, the repair was put back into service after only three and one half hours of cure.
