# BELZONA PERMANENTLY SECURES HANDRAIL POSTS

ID: 327

Customer Location: Municipal sewage treatment facility in Minnesota, USA

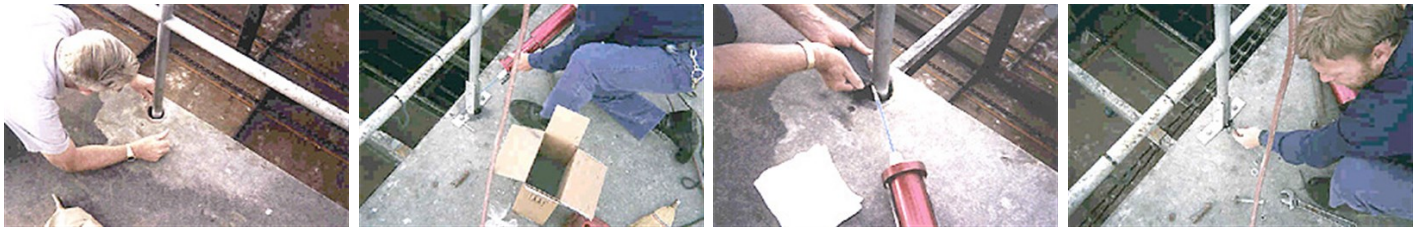
## Photograph Descriptions

Liquid was pooling around these handrails, spalling the concrete and loosening the rails at this municipal sewage plant to such an extent that worker safety was in question.

- \* Removing loose debris from the handrail post/concrete interface ,
- \* Injecting Belzona® 4151 into the handrail post hole ,
- \* Filling in the irregularity with the aggregate ,
- \* Finished repair by mounding the resin to the shed water ,

Spalled concrete around handrail posts at a sewage treatment plant.

The application was carried out in accordance with Belzona Know-How System Leaflets FPA-10.

Other cementitious-based repair materials shrink and crack, often allowing liquid a path to migrate through. This causes further spalling in a relatively short period of time.
