FAN BLADE EDGES REBUILT WITH BELZONA

Industry: Power
Application: FBC-Fans, Blowers and Compressors

Customer Location: Power plant in Mississippi, USA
Application Date: February 2002

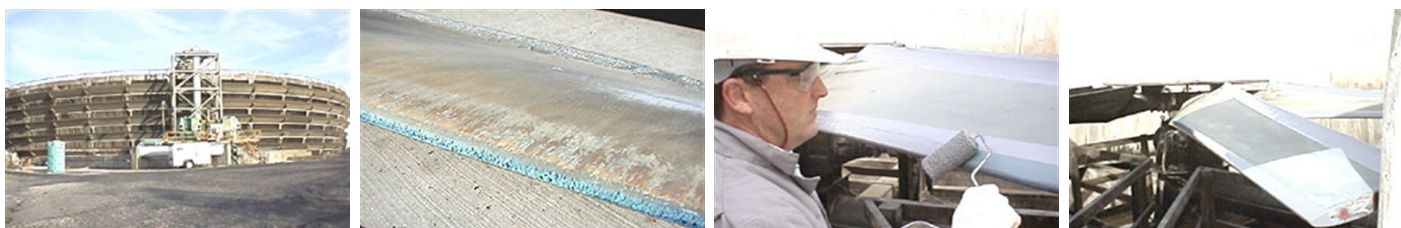
Photograph Descriptions

Erosion of both the leading and trailing edges of cooling tower fan blades, caused inefficient tower operation and raised concerns about blade replacement in the near future.

- * View of the huge cooling tower ,
- * Close-up of the fan blade damage ,
- * Application with small roller ,
- * Finished application ,

The application was carried out in accordance with Belzona Know-How System Leaflet FBC-1.

This huge cooling tower has ten individual cells. Each cell contains eight cooling tower blades, and all ten cells were refurbished with the afore-mentioned Belzona Know-How technique.
