BELZONA CAVITATION RESISTANCE FOR IMPELLER

ID: 33

40-inch impeller for cooling tower pump

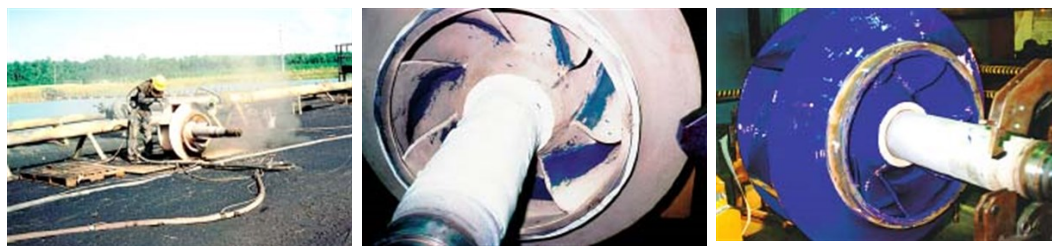
Photograph Descriptions

Severe damage to the impeller caused by cavitation

- * Surface preparation—abrasive grit blasting in progress ,
- * Cavitated areas of the impeller rebuilt with Belzona® 1311 ,
- * Application of Belzona® 1421 complete, impeller ready for service ,

The application was carried out in accordance with Belzona Know-How Leaflets CEP-1 and CEP-3.
