# BELZONA CAVITATION RESISTANCE FOR IMPELLER

ID: 33

Customer Location: Oil Refinery in Mississippi  
Application Date: August 1995

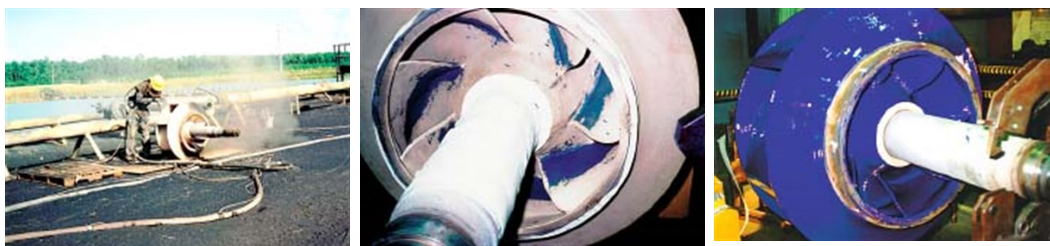
Severe damage to the impeller caused by cavitation

- \* Surface preparation&mdash;abrasive grit blasting in progress ,
- \* Cavitated areas of the impeller rebuilt with Belzona® 1311 ,
- \* Application of Belzona® 1421 complete, impeller ready for service ,

40-inch impeller for cooling tower pump

The application was carried out in accordance with Belzona Know-How Leaflets CEP-1 and CEP-3.
