BELZONA SEALS GEARBOX DOORS TO ELIMINATE OIL LEAKS

ID: 332

Gearboxes on the end of looms.

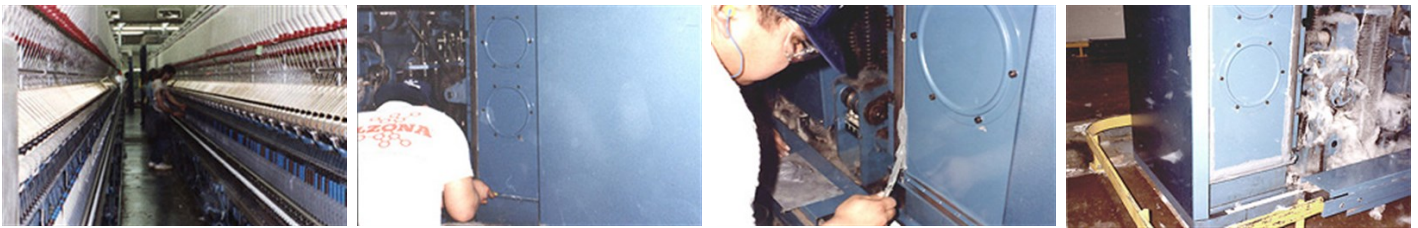
Photograph Descriptions

Oil leaks around seams and gearbox doors were causing safety problems at several locations where this equipment was in operation; including the Southeast U.S. and Japan.

- * A view of the loom in operation ,
- * Cutting gasket material away from seams ,
- * Applying Belzona® 1211 (E-Metal) over the seams ,
- * Completed application around the bottom of the door below oil level ,

The use of Belzona® 1211 allowed the machine to be put back in service with only 30-minutes of downtime for the entire repair. Each unit was repaired with one, 500 gram package of material. A total of 53 units have been repaired in the U.S. alone. This specific repair scenario was first completed in Japan.
