# FÖRDERBAND-REPARATUR MIT BELZONA

Industrie: Leistung  
Anwendung: Maschinen zur Handhabung von Feststoffen  
Substrat: Gummi  
Produkte: \* Belzona 2311 (SR Elastomer),

Standort des Kunden: Kraftwerk, Bulgarien  
Antragsdatum: August 2002

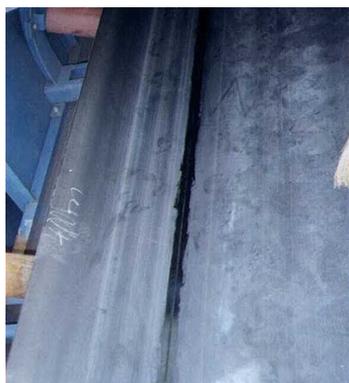
Durch einen mechanischen Schaden am Bandabstreicher wurde die Metallverstärkung freigelegt.

- \* 1. Ansicht der Förderanlage ,
- \* 2. Grundierung mit Belzona 2911 (Elastomer QD Conditioner) ,
- \* 3. Reparatur mit Belzona 2311 (SR Elastomer) ,
