BELZONA REPAIRED PUMP LASTS SIX TIMES LONGER THAN A NEW PUMP.

Customer Location: *Pulp and paper mill in Thunder Bay, Ontario*

Application: *CEP-Centrifugal Pumps*

316 Stainless Steel Lime Sludge Pump

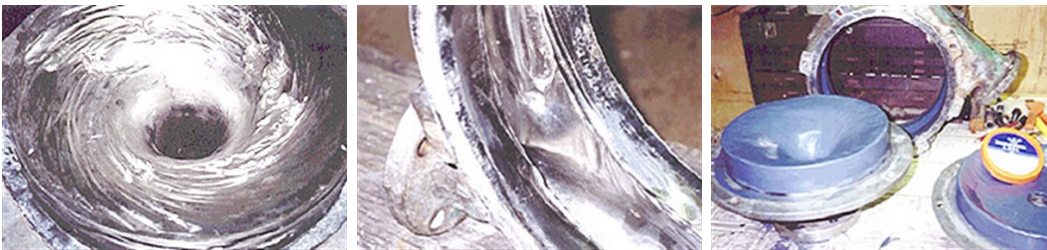
Photograph Descriptions

The abrasive material was deteriorating the stainless steel and was only lasting six to seven months and costing as much as \$14,000 to replace.

- * Damaged steel end plate ,
- * Abraded end suction casing ,
- * Rebuilt and coated lime sludge pump ,

The application was carried out in accordance with Belzona Know-How System Leaflets CEP-3 and CEP-5.

The repair usually lasts seven cycles (three to three and one half years), otherwise the \$14,000 pump has to be replaced twice a year.
